PERFORMANCE OF LI-1542 REUSABLE SURFACE
INSULATION SYSTEM IN A HYPERSONIC STREAM

by L. Roane Hunt and Herman L. Bohon

April 1974

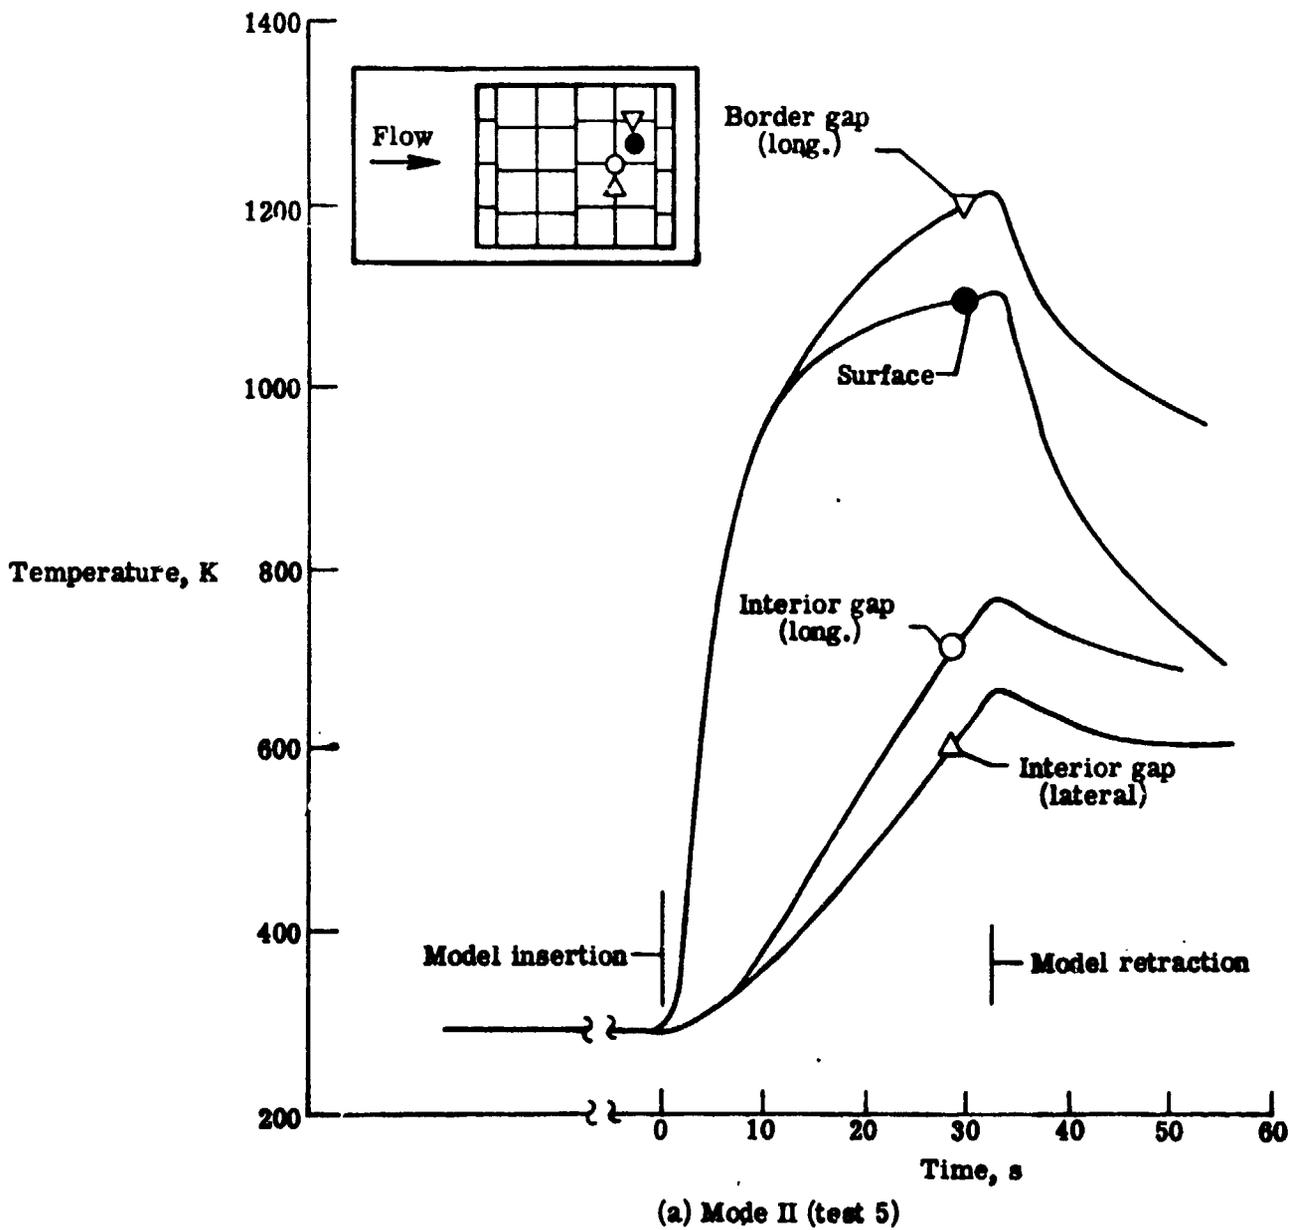
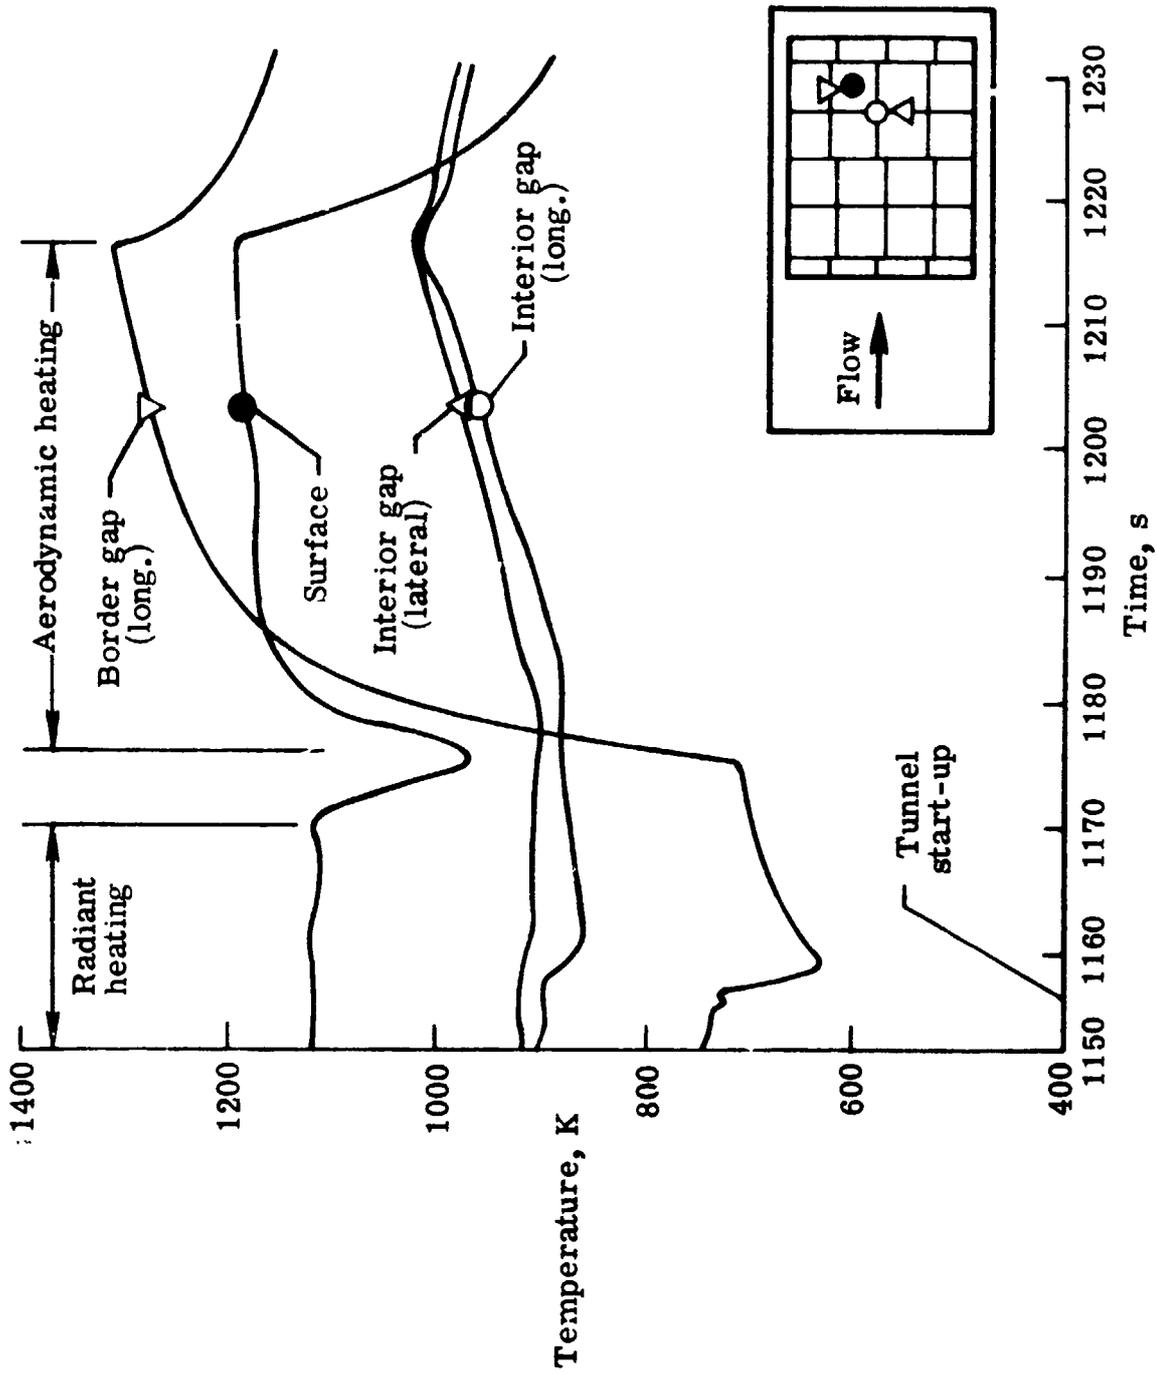
Figure 11.- Typical thermal response of panel to aerodynamic heating.

(b) Mode III (test 8)

Typical thermal response at four tile locations is shown in figure 11(a) for a mode II test (test 5) and in figure 11(b) for the aerodynamic phase of a mode III test (test 8). These locations, indicated by the inset, include the tile surface, a longitudinal border gap, and longitudinal and lateral interior gaps.

The thermal response of the border gap and the tile surface is more rapid than that of the interior gaps as indicated in figure 11(a). The maximum temperature of the border gap exceeds that of the surface. The

The temperature history shown in figure 11(b) includes a portion of radiant heating for orientation. The tunnel was started while the lamps were on. During tunnel start, the local static pressure is reduced from atmospheric pressure of 100 kPa to 1.5 kPa in about 5 seconds, and the cool ambient air in the cavity beneath the panel escapes through the thermal seals along the border gaps as reflected by the sharp reduction in border gap temperature. The corresponding interior gap temperatures dropped slightly and the panel surface temperature remain unchanged during this reduction in static pressure. After model insertion, the surface temperature quickly reaches steady-state, or radiation equilibrium, and the border gap temperature (as noted in figure 11(a)) again exceeds the tile surface temperature.

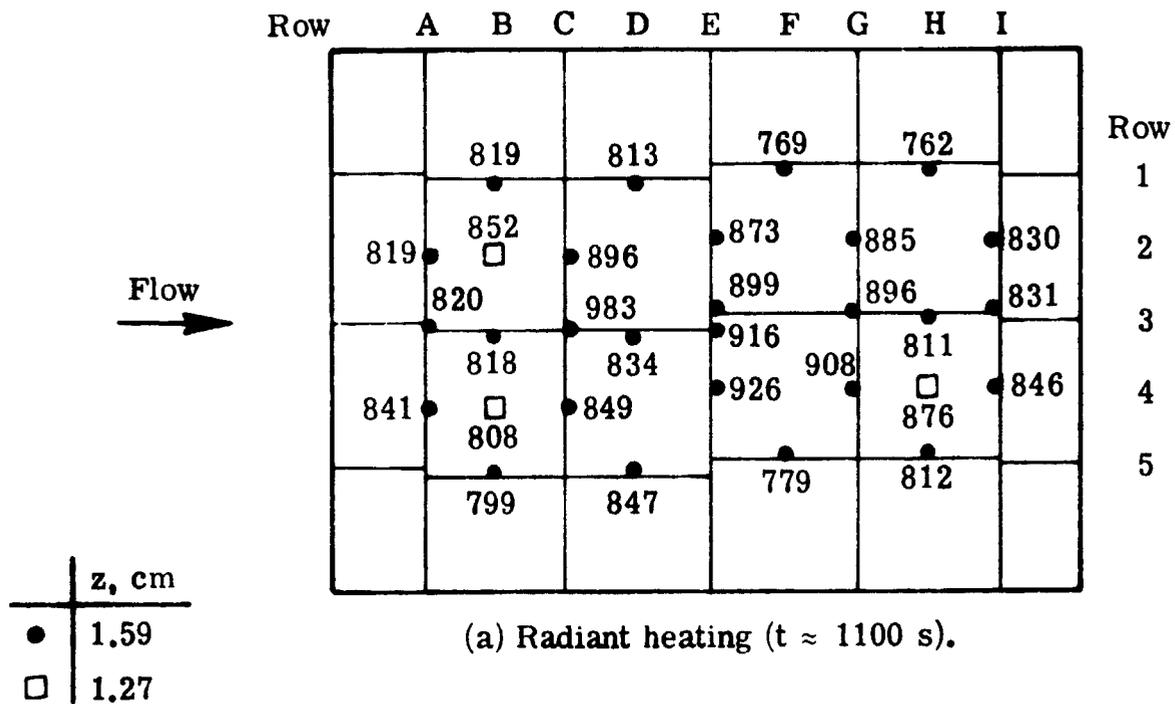
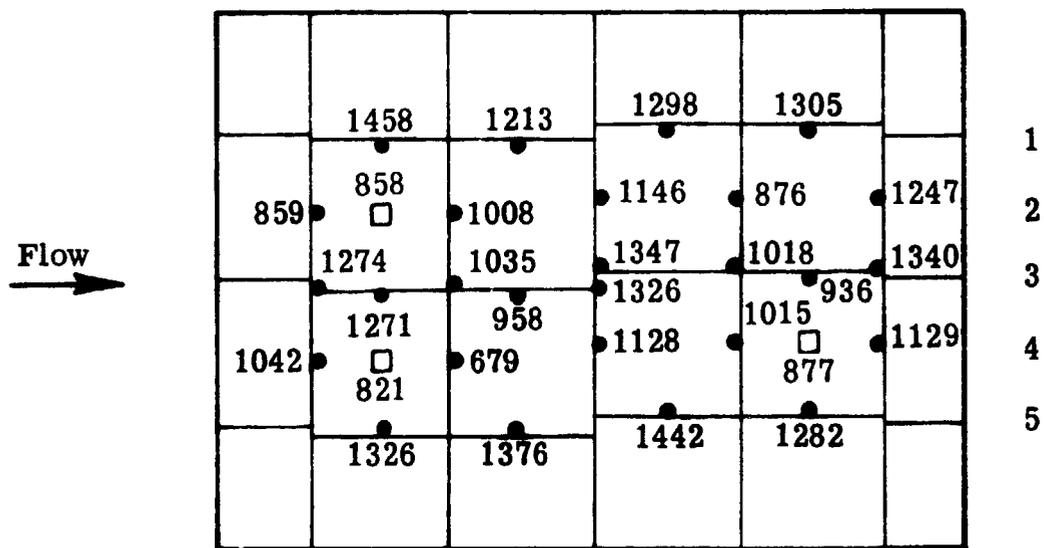
(a) Radiant heating ($t \approx 1100$ s).

(b) Aerodynamic heating ($t = 1215$ s)

Figure 12.- Typical temperatures (K) for mode III test (test 8).

The gap temperatures (solid symbols) and tile temperatures at a depth of 1.27 cm (square symbols) for test 8 are displayed on plan views of the tile array in figure 12. These temperatures are listed in tables IV and V. For comparison, the temperatures recorded at $t = 1100$ seconds into the radiant heating phase are presented in figure 12(a) and corresponding temperatures recorded at $t = 1215$ seconds (see time scale of figure 11(b)) are presented in figure 12(b). Generally, the temperatures shown in figure 12(a) are relatively uniform at about 800 K as compared to a surface temperature of approximately 1100 K (table IV). As indicated in figure 12(b), the temperature changed radically during the aerodynamic heating phase.

Temperatures near 1400 K were recorded along the longitudinal border gaps (rows 1 and 5); however, temperatures of the interior gaps (both longitudinal and lateral) were generally around 900 K to 1000 K. The high temperatures at the "header" region - that is, the forward-facing wall at the end of longitudinal gap (for instance, the intersections of rows A3, E3, and I3) - were about 1350 K. The gap temperatures of the header region were expected to be higher than the other gap temperatures because the header region served as a stagnation surface for longitudinal gap flow. The lateral gap temperatures adjacent to the headers in rows A, E, and I are 100 K to 200 K less than the header temperatures, but are generally greater than the interior gap temperatures.

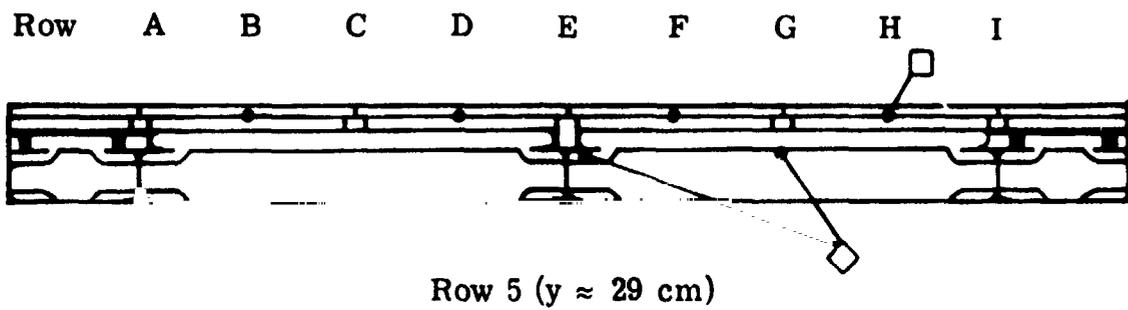
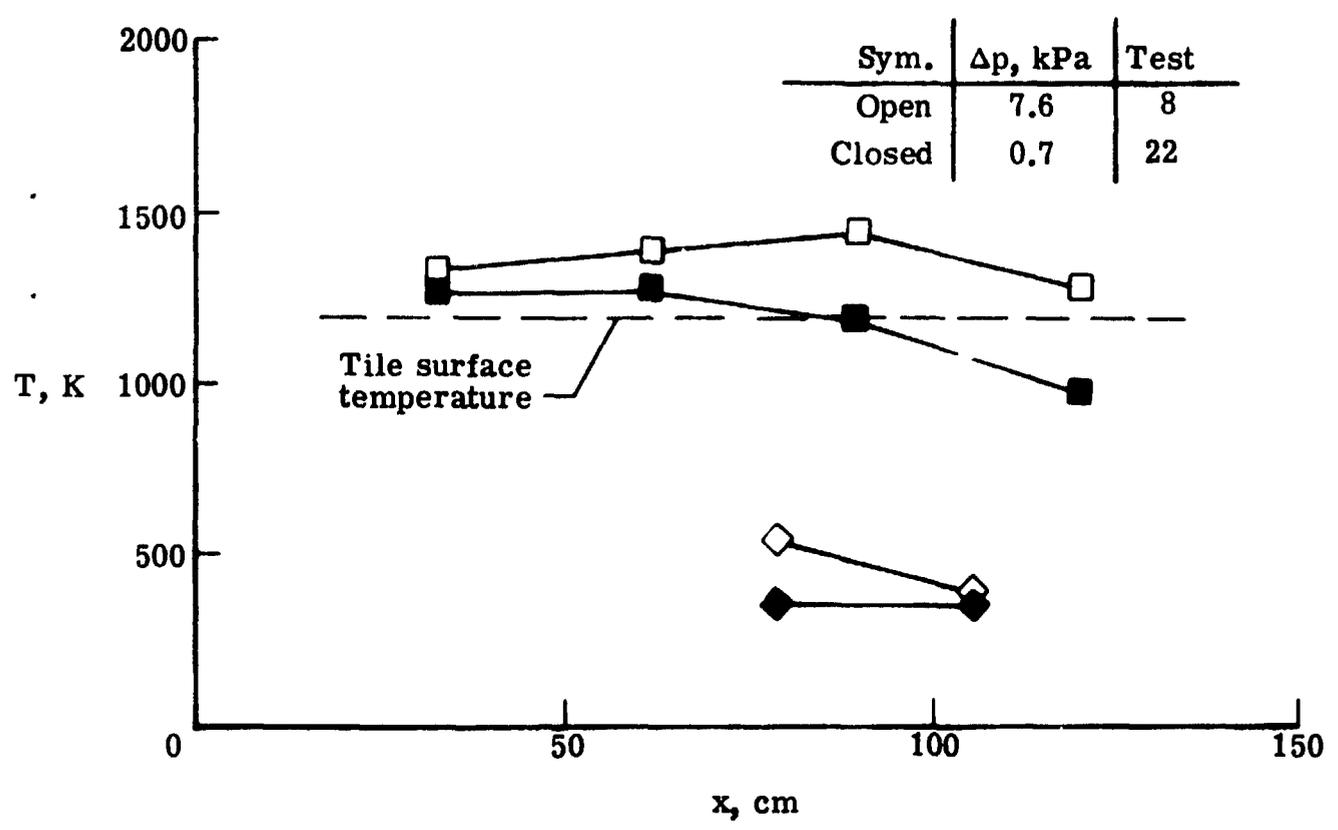
Figure 13.- Effects of differential pressure on gap and substructure temperature along row 5 after 40 s of aerodynamic heating.

The longitudinal border and subpanel gap temperatures were considerably higher than expected and suggest increased gap flow due to leakage through the thermal seals which permitted hot gas flowthrough to the substructure. The border gap temperature distribution along row 5 is shown in figure 13 for two differential pressure loadings, $\Delta p = 7.6$ kPa (test 8) and Δp (test 22). The difference in the temperature levels is indicative of increased gap flow as a result of seal leakage. Reducing the differential pressure resulted in a 100 K to 300 K reduction in border gap temperatures. The substructure temperature at E5 was 500 K during run 8 ($\Delta p = 7.6$ kPa) but only 300 K during test 22 ($\Delta p = .7$ kPa). Consequently, hot gas was apparently leaking to the substructure at E5 where lateral and longitudinal border seals meet. The effects of flow leakage along the longitudinal border gaps on lateral gap temperatures are shown in figure 14 where temperatures along row E are plotted for tests 8 and 22. The header temperature at $y = 0$ is

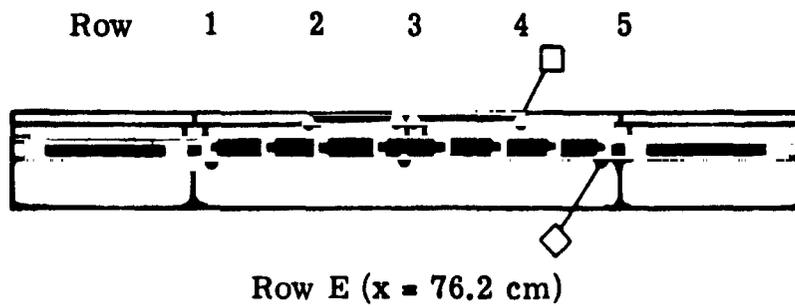
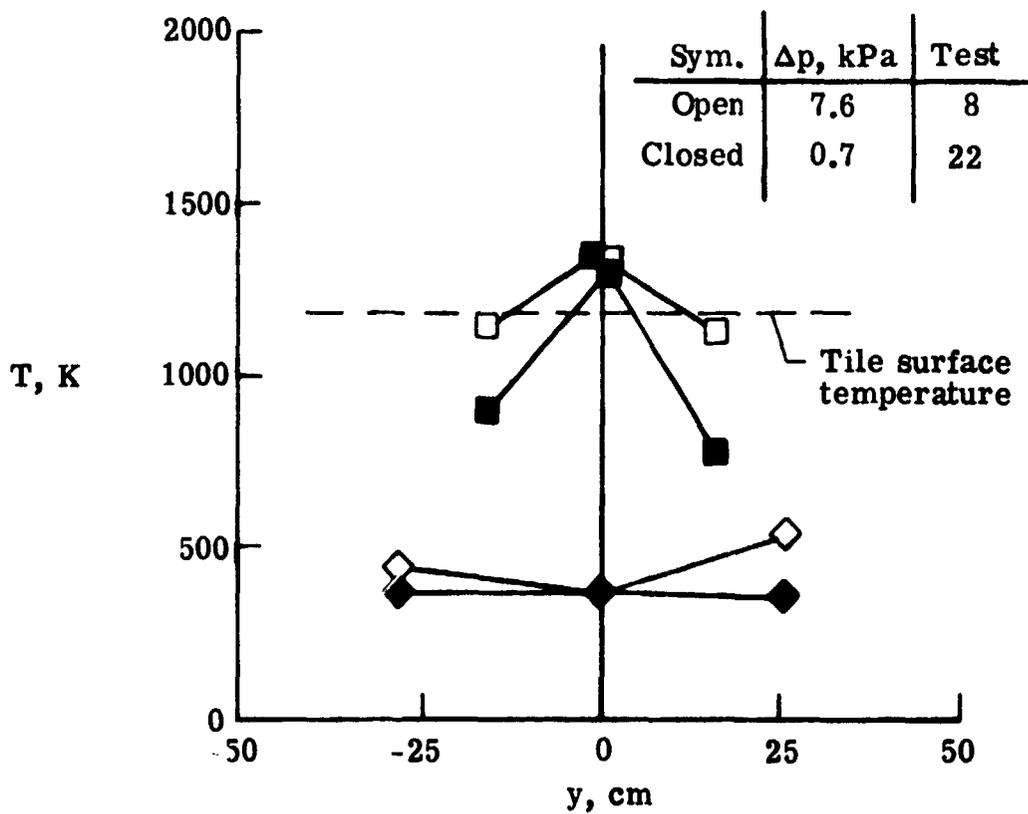
Figure 14.- Effects of differential pressure on subpanel gap and substructure temperature along row E after 40 s of aerodynamic heating.

unaffected by Δp . However, the adjacent temperatures, about 15 cm on each side, show 200 K to 300 K reductions when Δp is reduced. Note the difference in the substructure temperatures indicates flowthrough at both corners E1 and E5. These data strongly suggest that gas leakage at the corners causes gap flow transverse to the stream direction. The influence of transverse flow on gap temperature is dependent on the energy of flow in the longitudinal gap approaching the header, which is characterized by the temperature and pressure at the header region.

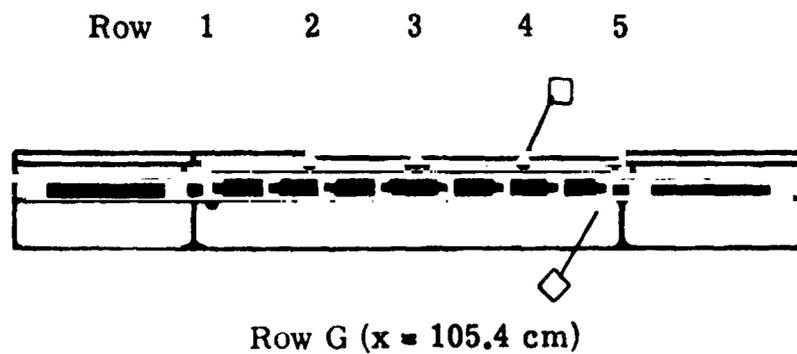
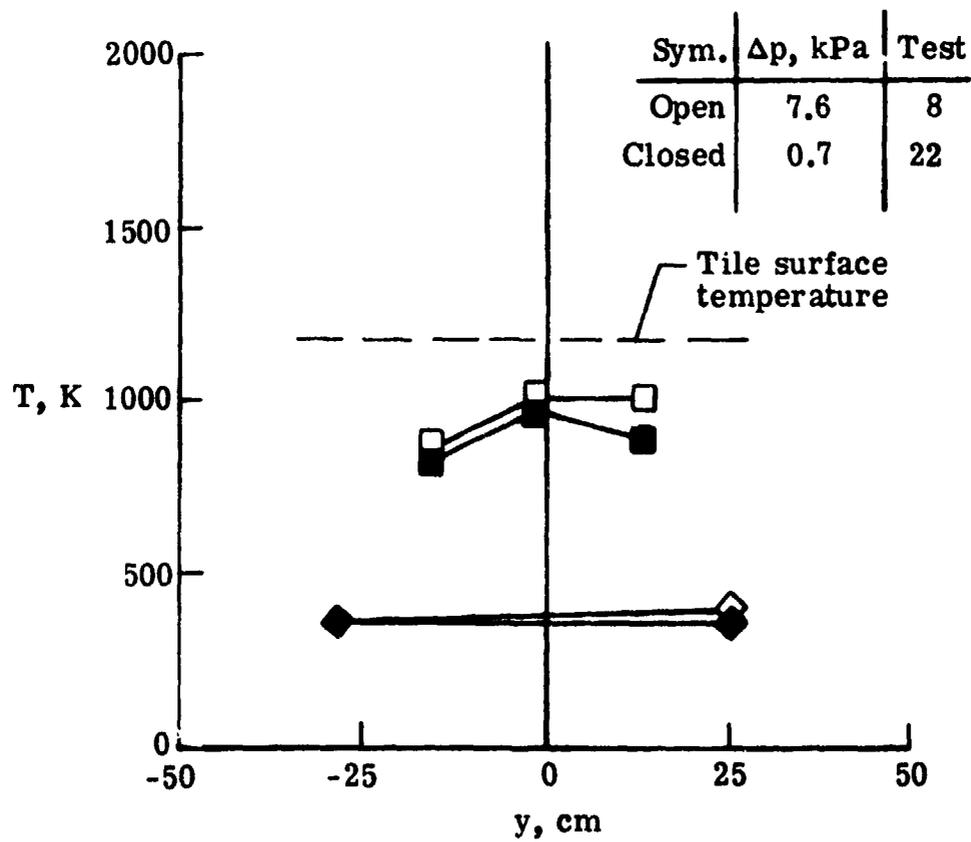
Figure 15.- Effects of differential pressure on interior gap and substructure temperature along row G after 40 s of aerodynamic heating.

The interior panel lateral gap temperatures in row G are shown in figure 15 for tests 8 and 22. Here, the effect of pressure gradient is seen to be small due primarily to the absence of an offset (or header) in the longitudinal gap at the center of the subpanel.

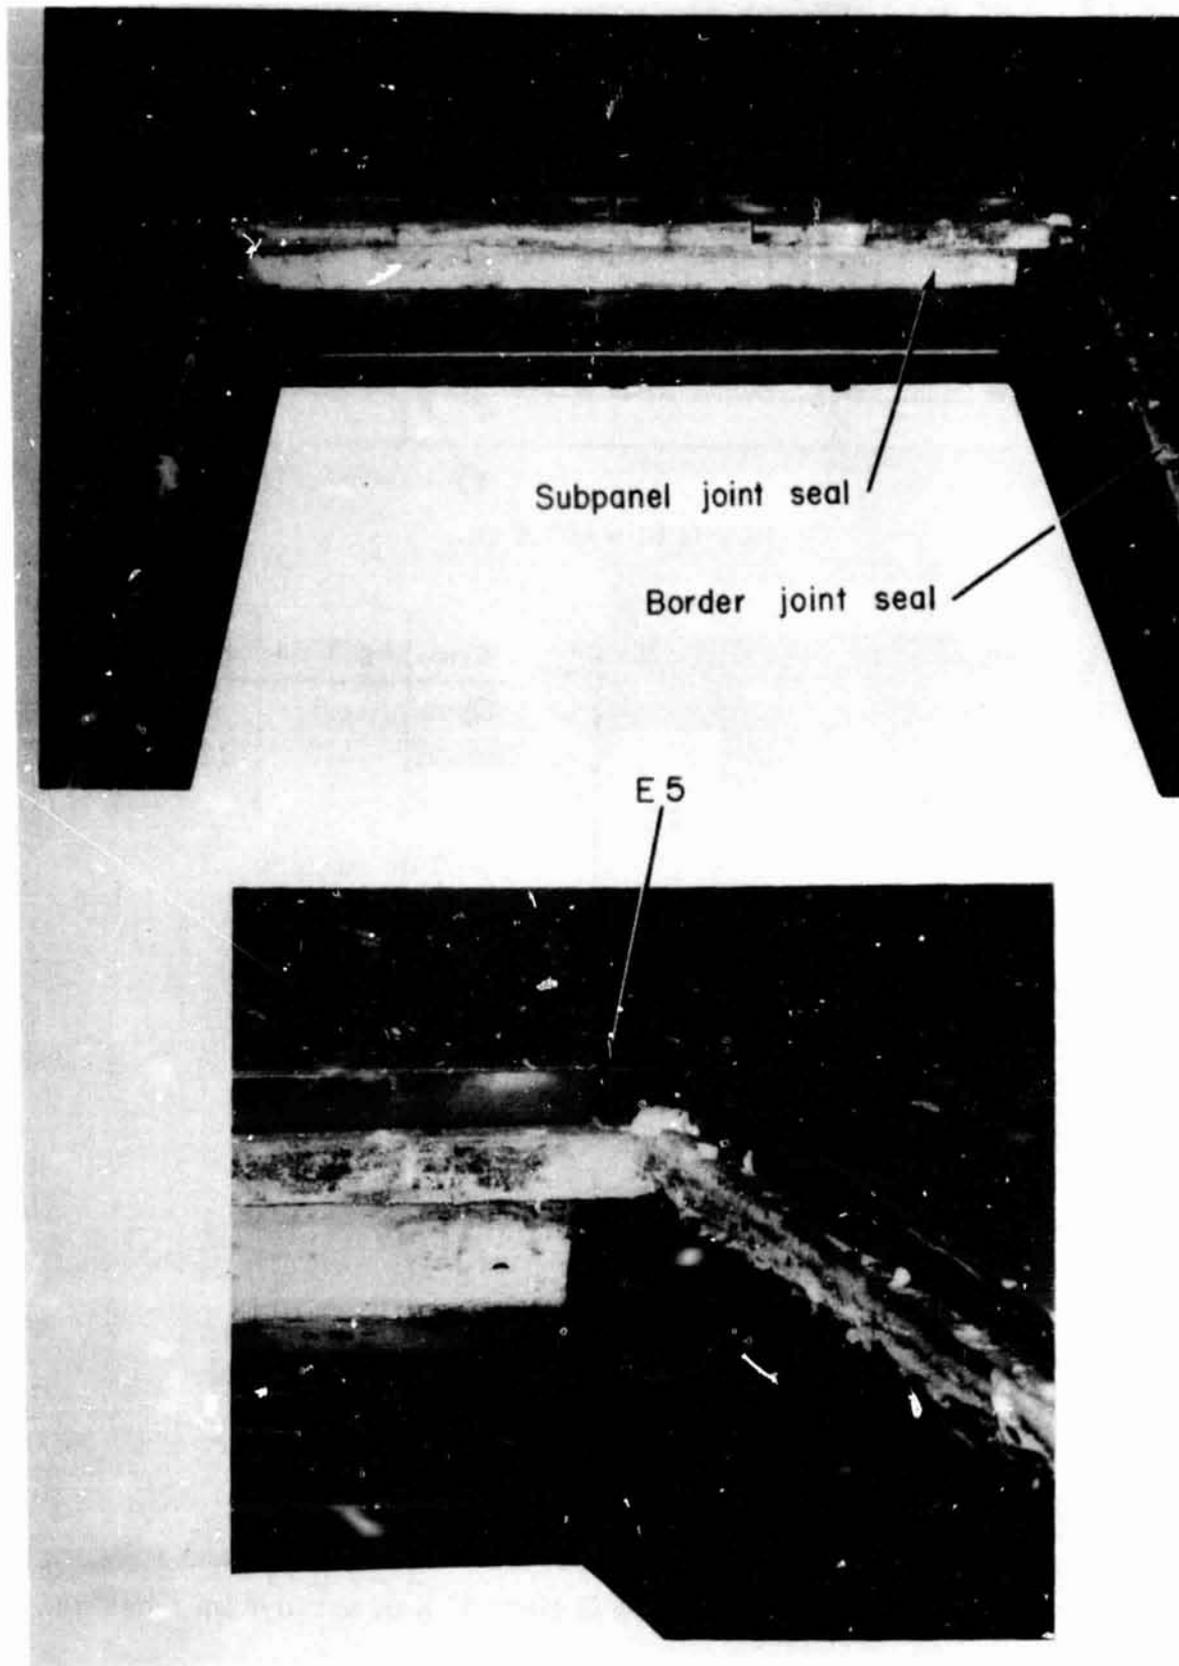
Figure 16. - Photographs of thermal seals of subpanel joint E5 at conclusion of tests.

After completion of all the tests, the panel was disassembled to examine the regions where hot gas flowed through the thermal seals. The tile array with the forward subpanel removed is shown in figure 16. Much of the fibrous thermal seal was damaged during disassembly. The deep seal in the lateral gap (row E) does not extend to the corner (E5) where high substructure temperatures were noted in figure 14. Evidence of hot gas flow in this region includes an appearance of scrubbing action on the thermal seal and discoloration of the substructure caused by out-gassing of the RTV bond material.

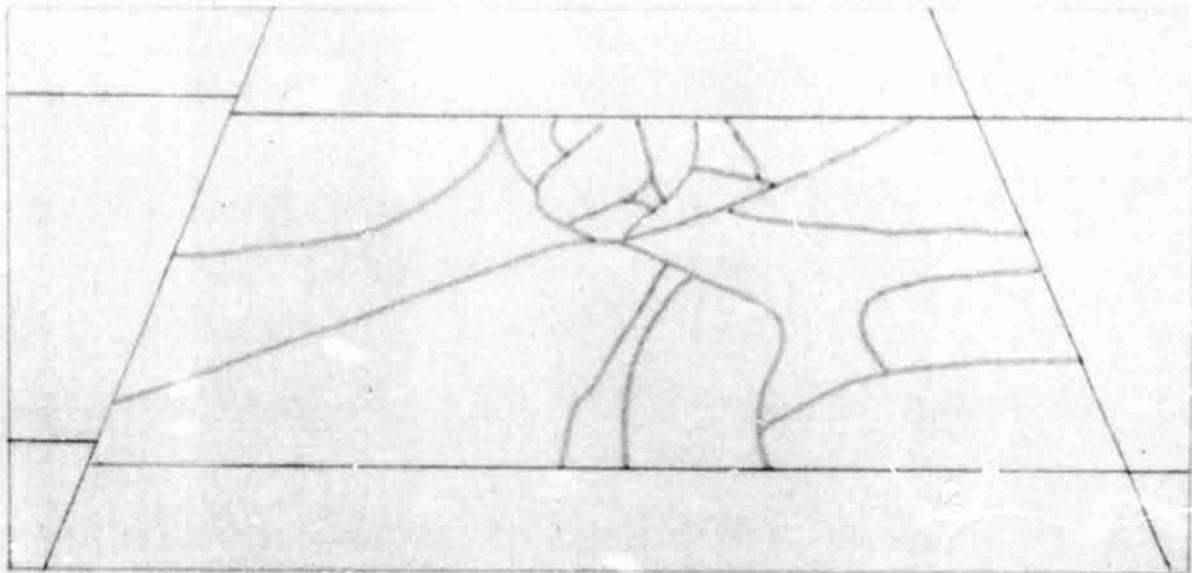
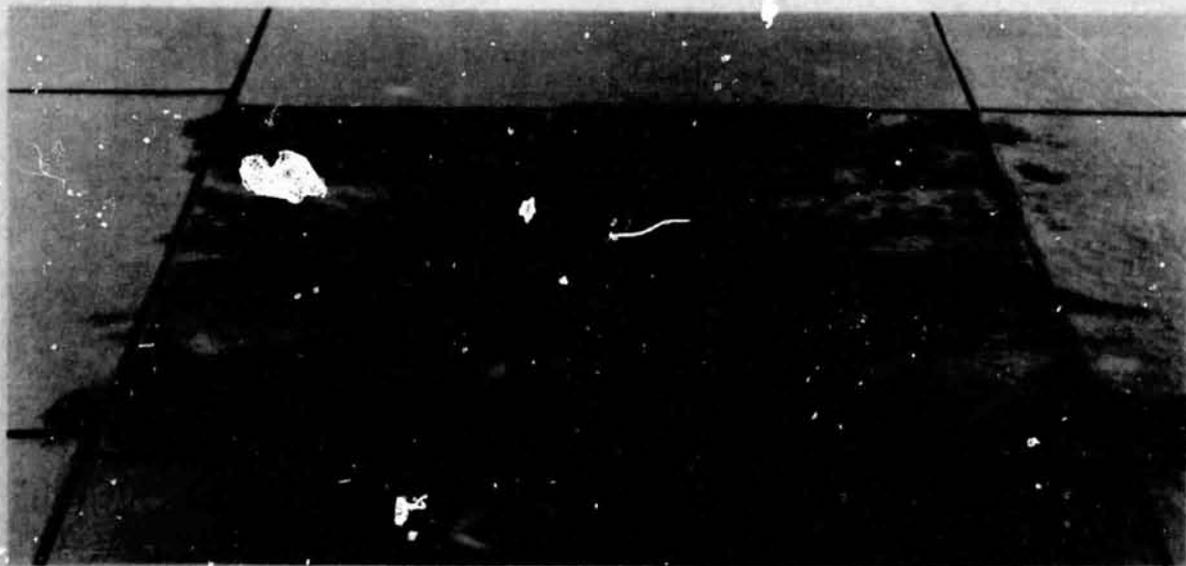
(a) Pre-test 4

(b) Post-test 4

Figure 18. - Crack patterns of tile coating (tile III).

Tile protective coating damage. - The coating is intended to protect the tile from water ingress and to prevent shear erosion of the basic silica tile. Although invisible to the naked eye, cracks were found in the coating before test 4, as indicated in figure 18(a) where the crack pattern is traced on a transparency. During test 4, tunnel flame-out occurred after 6.2 seconds in the stream (see table II); consequently, the hot tiles were exposed to extremely cold flow. A photograph of a typical tile crack pattern after test 4 is shown in figure 18(b). The tile is wetted by a volatile solvent to expose the hairline cracks. All of the tiles were crazed as shown in figure 18(b) after run 4, but did not seem to worsen with repeated tests. There was no flaking of the RSI which suggests the cracks did not penetrate the basic silica tile.

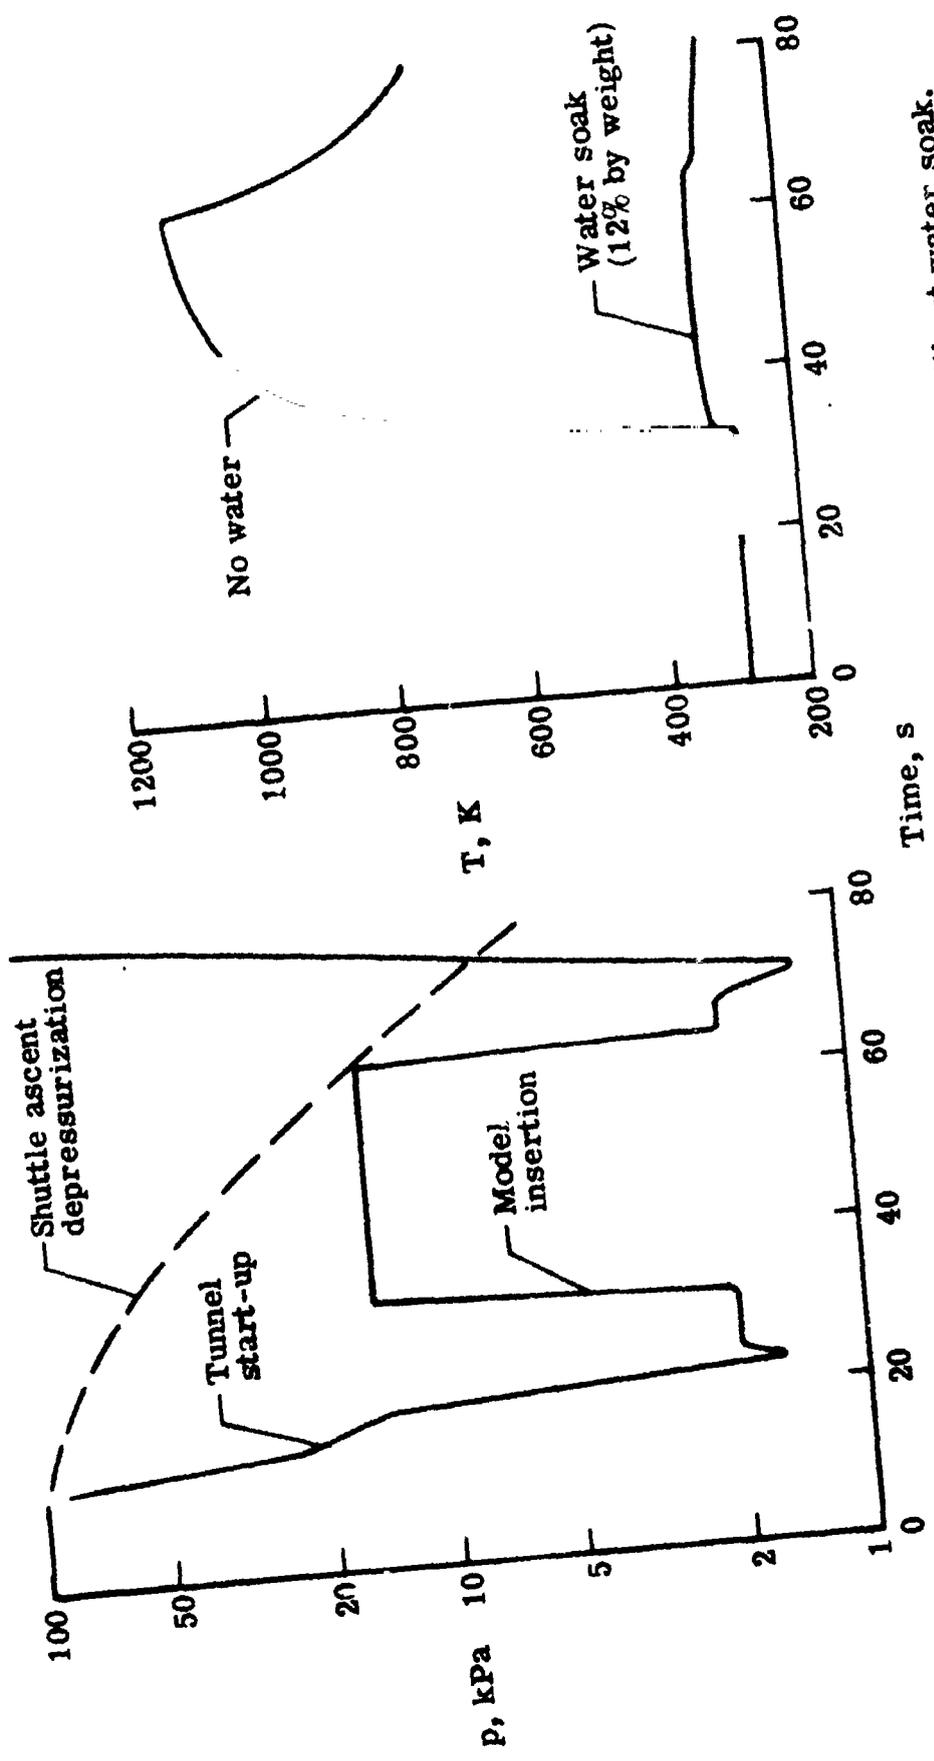
Figure 19.- Pressure-temperature history of LI-1542 tile with and without water soak.

Effects of water soak. - Since the coating crazed and consequently could allow water ingress, tiles VI and VIII were soaked with water for test 23 to determine its effect on tile integrity during rapid change in pressure and temperature. The static pressure and temperature histories for tile VIII are shown in figure 19. The depressurization from 100 kPa to 1.5 kPa occurs during tunnel startup and is followed by a pressure increase as the model is inserted into the stream. For comparison, the Shuttle ascent depressurization rate is shown by the dashed curve. The surface temperature histories

of the soaked tile and an adjacent tile (tile V) with no water are shown on the right of the figure. The temperature of the soaked tile leveled off at the boiling point of water at the local static pressure. However, it is possible that the thermocouple in the soaked tile was shorted by the water; consequently, the surface temperature may have been greater than that shown. Nevertheless, an excessive amount of water was absorbed in the tile and the depressurization rate experienced by the tile was extreme without any evidence of damage to the tile surface.

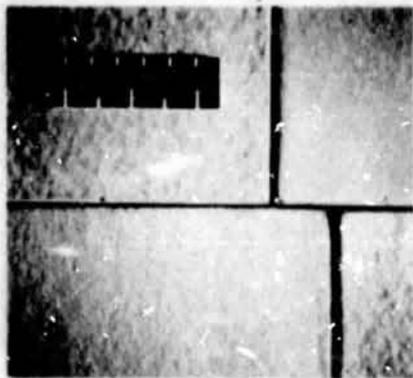
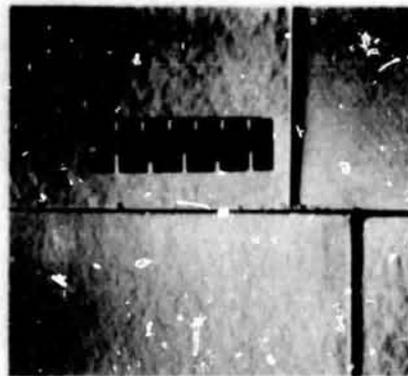
(a) Post test 2

(b) Post test 13

Figure 21. - Tile edge erosion of 0.6 mm forward-facing step at E3.

Edge erosion. - The tile assembly had forward-facing steps at two locations; each of which experienced erosion along the tile edges. The progression of edge erosion of a .6 mm step and a .4 mm step is shown in figures 21 and 22, respectively. The propagation of the edge erosion was probably enhanced by foreign particle impact, however, the erosion rate was slow and exposure

of the bare silica to the stream did not result in catastrophic failure. Observation of movie film indicated the eroded edges became local hot spots because of the reduced value of emissivity in the absence of coating.

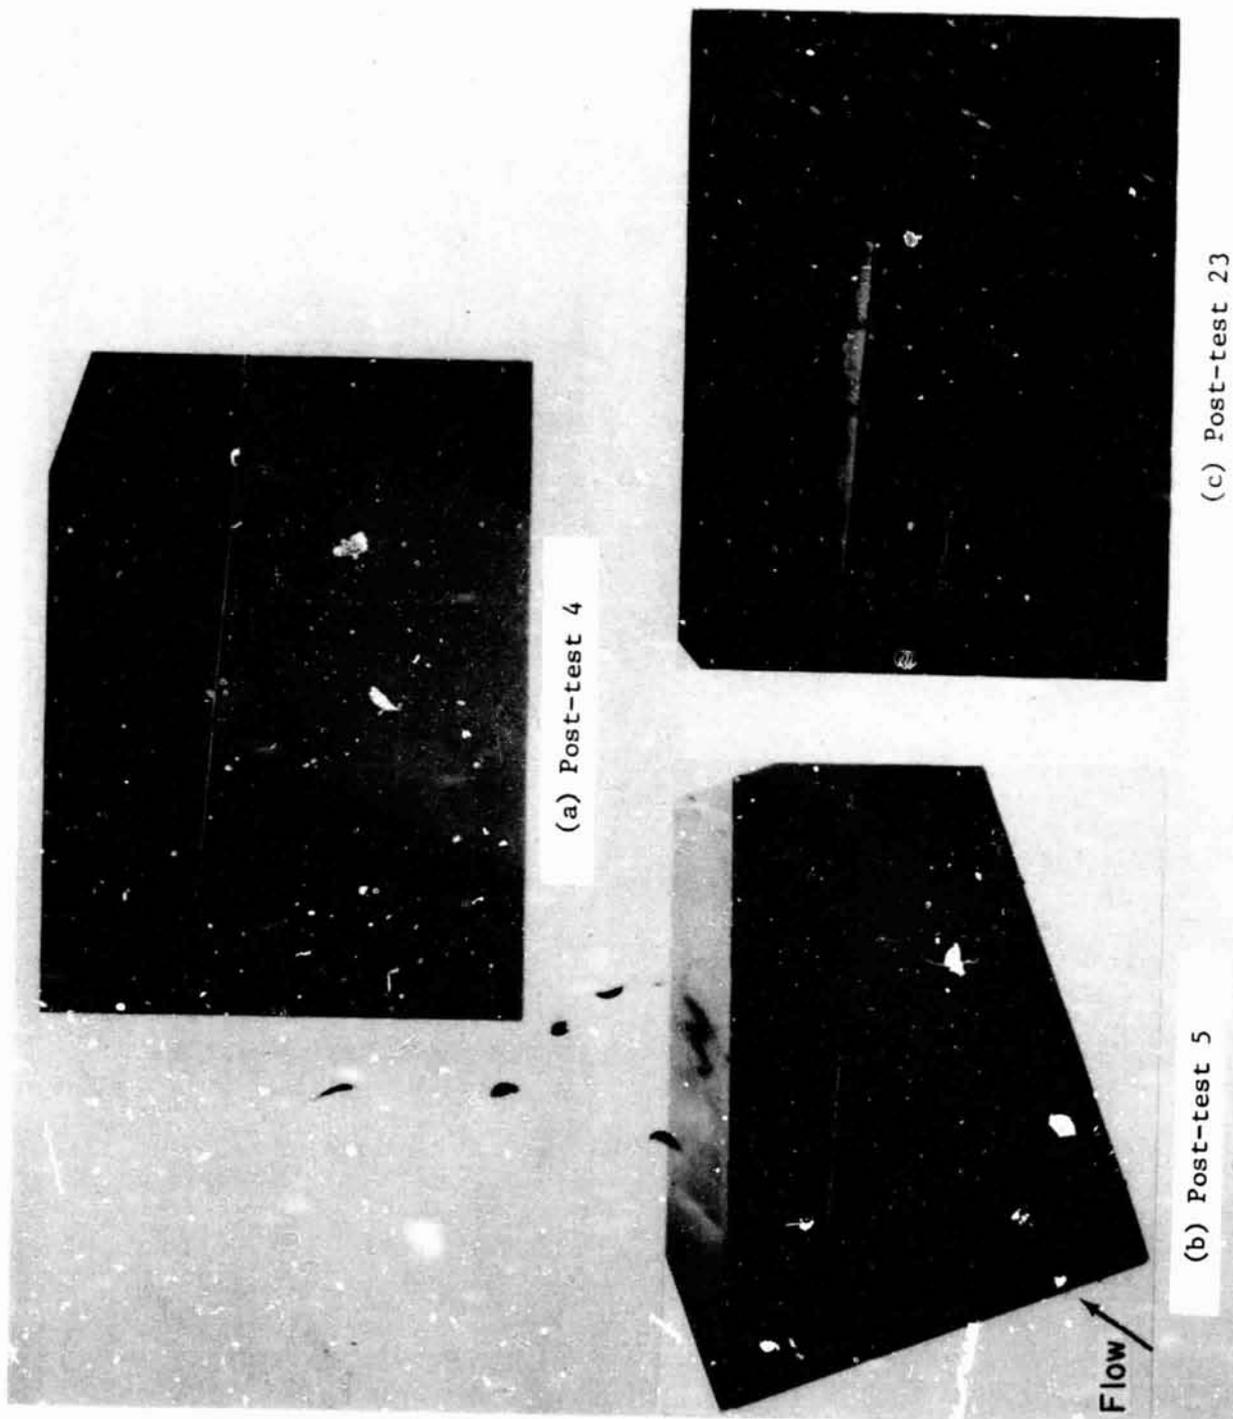
Figure 22. - Tile edge erosion of 0.4 mm forward-facing step along row I.

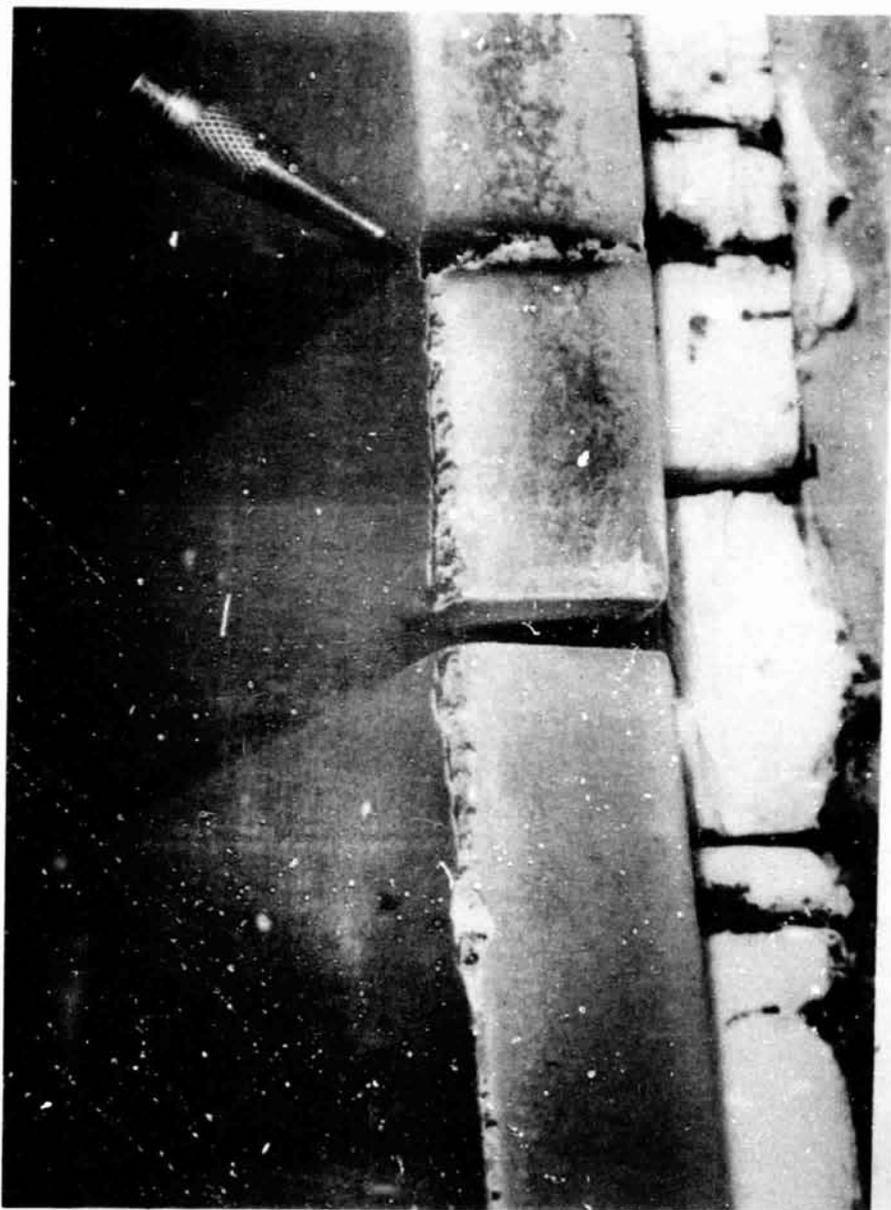
Figure 23. - Flow impingement damage of header at E3.

Flow impingement. - At least one type of damage which cannot be tolerated during a reentry is that due to hot gas impingement in the header region. As noted earlier, temperature at the bottom of the gaps in the header region measured about 1350 K. The resulting damage is shown in figure 23 where the forward-facing wall at the intersection of rows E3 has been eroded about 1 cm into the silica. The temperature in this region must have been near the melting temperature of the silica. This erosion and similar ones at other header regions are significant in the fact that the surface temperature of the tiles was only 1100 K. Consequently, along the bottom centerline of the Orbiter where surface temperatures are around 1600 K, impingement of gap flow on a forward-facing wall could be catastrophic.
